TEST REPORT

EN 13964 BALL GUN TEST

Customer:	Ewona Finland Oy
Device name:	Ewona Acustica® suspended ceiling plates Luxury HUSH 50mm

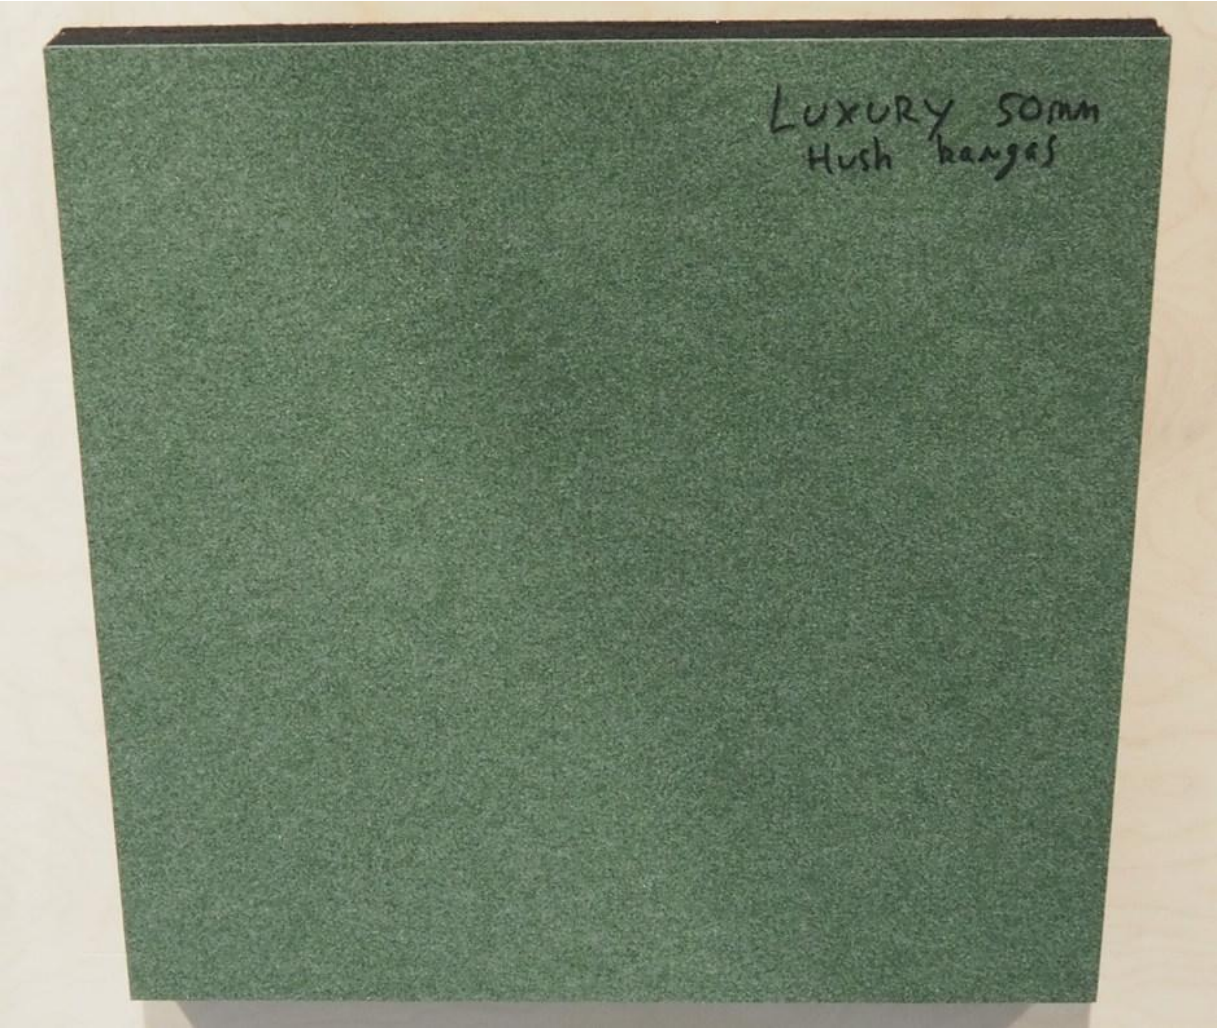
Figure 1. Suspended ceiling plates were attached to plywood before the test.

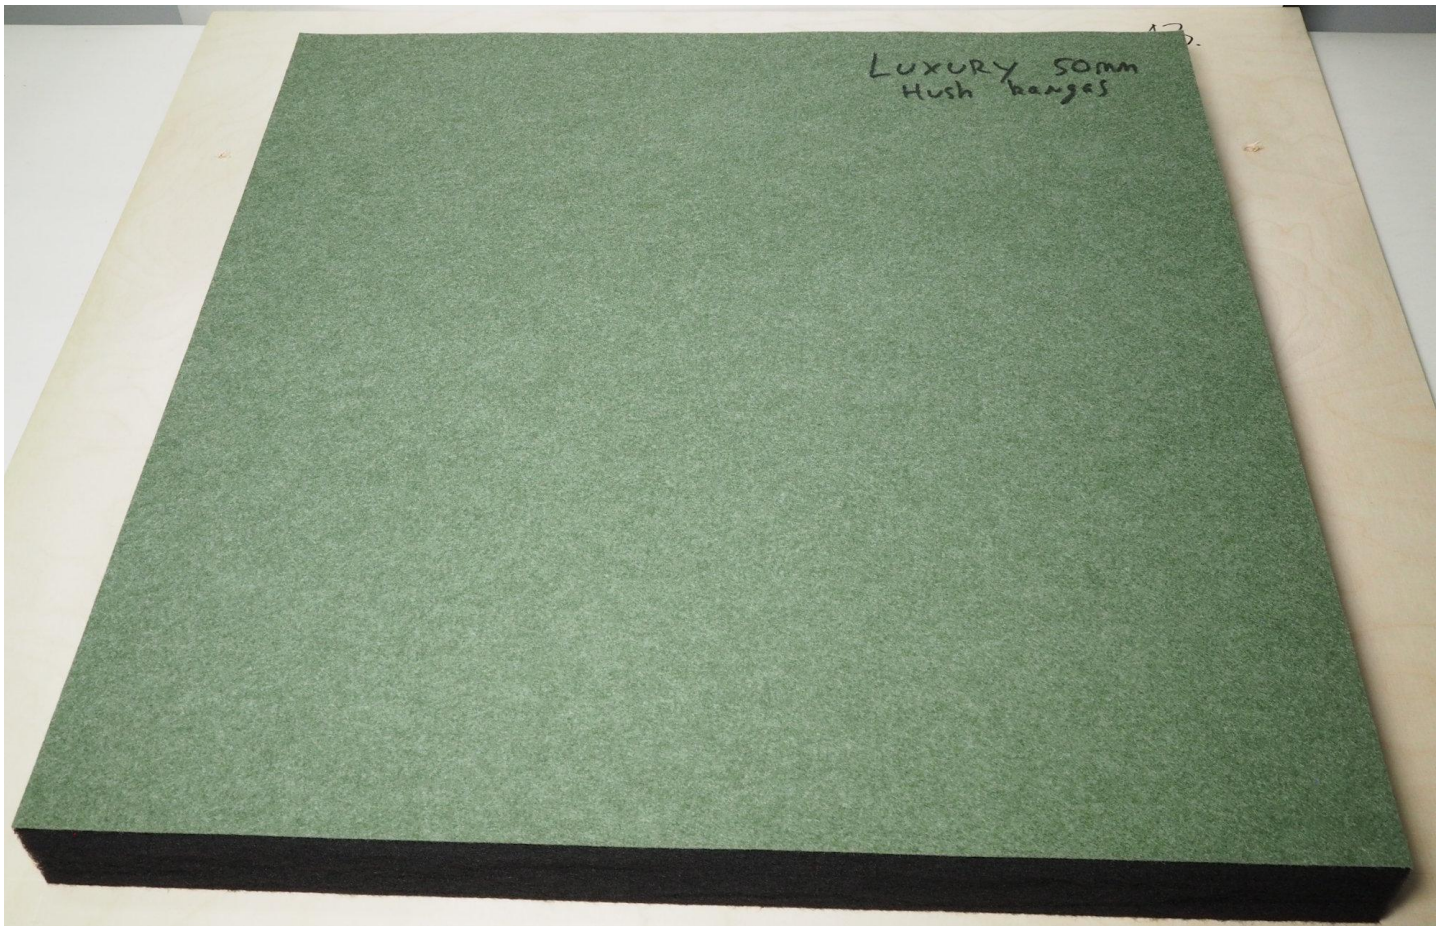
Figure 4. Sample 13 after the test. There were no mechanical and visual changes detected.

Figure 5. Sample 14 after the test. There were no mechanical and only visual changes detected.

Sample 13 functionality was not compromised and no visual defects detected.→ Test result is **pass.**

Sample 14 functionality was not compromised and no visual defects detected.→ Test result is **pass.**

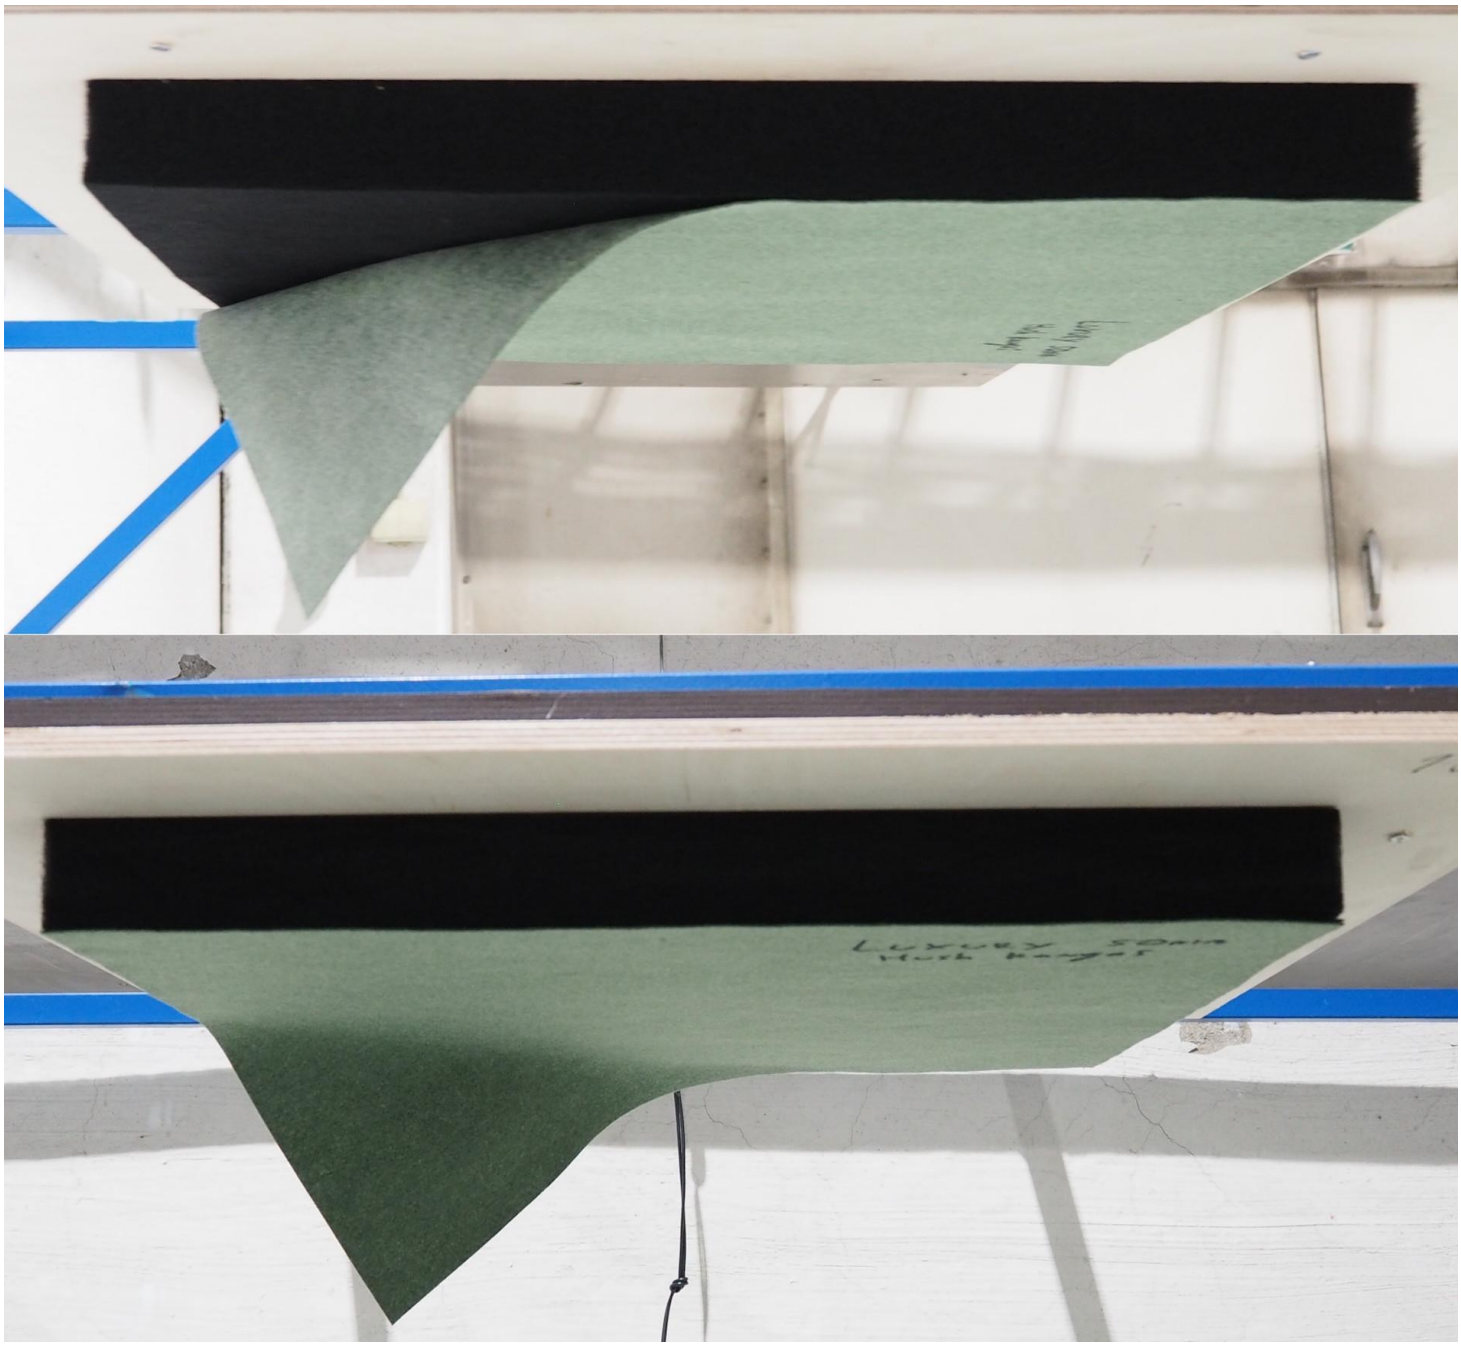
During the test Sample 15 cloth was detached on shot 21, see Figure 6. Test was continued, cloth did not detach more.

Figure 6. Sample 15 after 21 shots. Cloth was detached. No other defects.

Figure 7. Sample 15 after the test. Cloth was partly detached during the test, no other defects detected.

Sample 15 functionality was compromised. Cloth of the sample was partially detached during the test.→ Test result is **fail.**

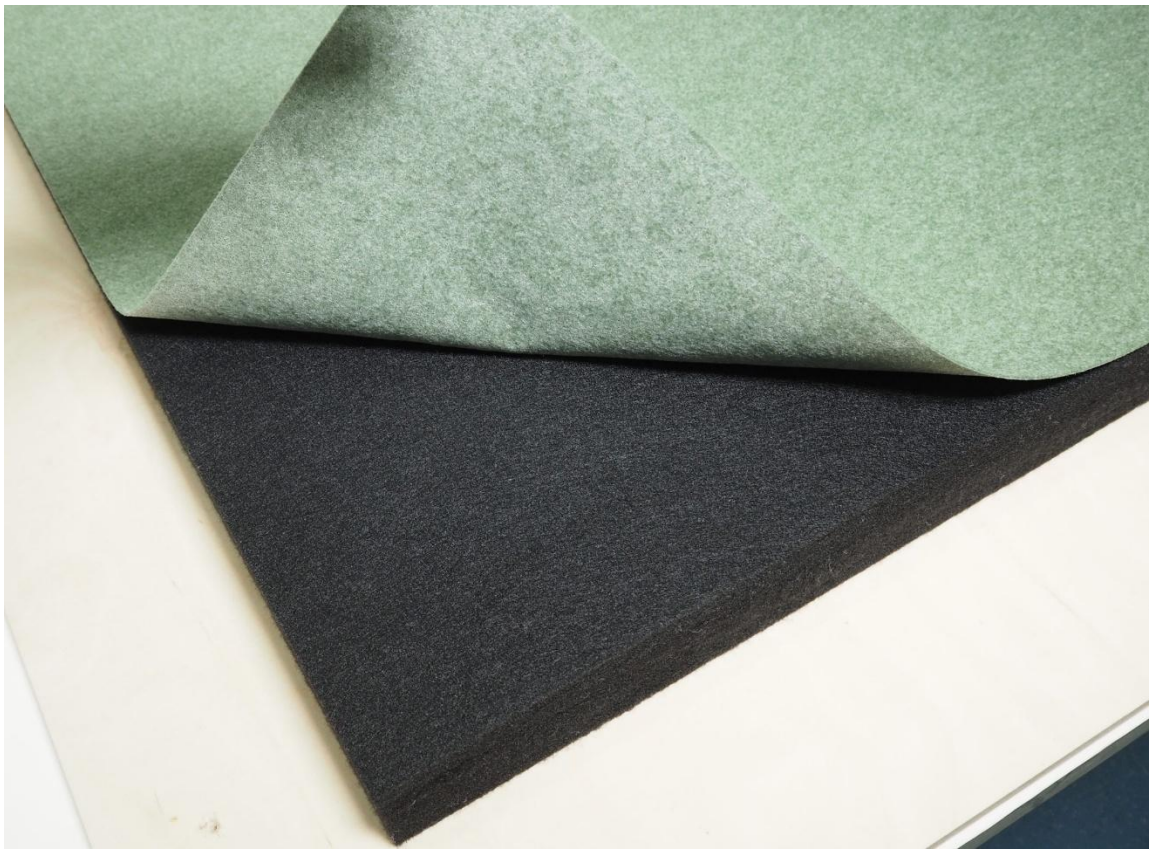
Figure 8. Sample 15 cloth partly detached.
