TOPTESTER OY

TEST REPORT

EN 13964 BALL GUN TEST

Customer:	Ewona Finland Oy
Device name:	Ewona Acustica® suspended ceiling plates Premium+ Madaline

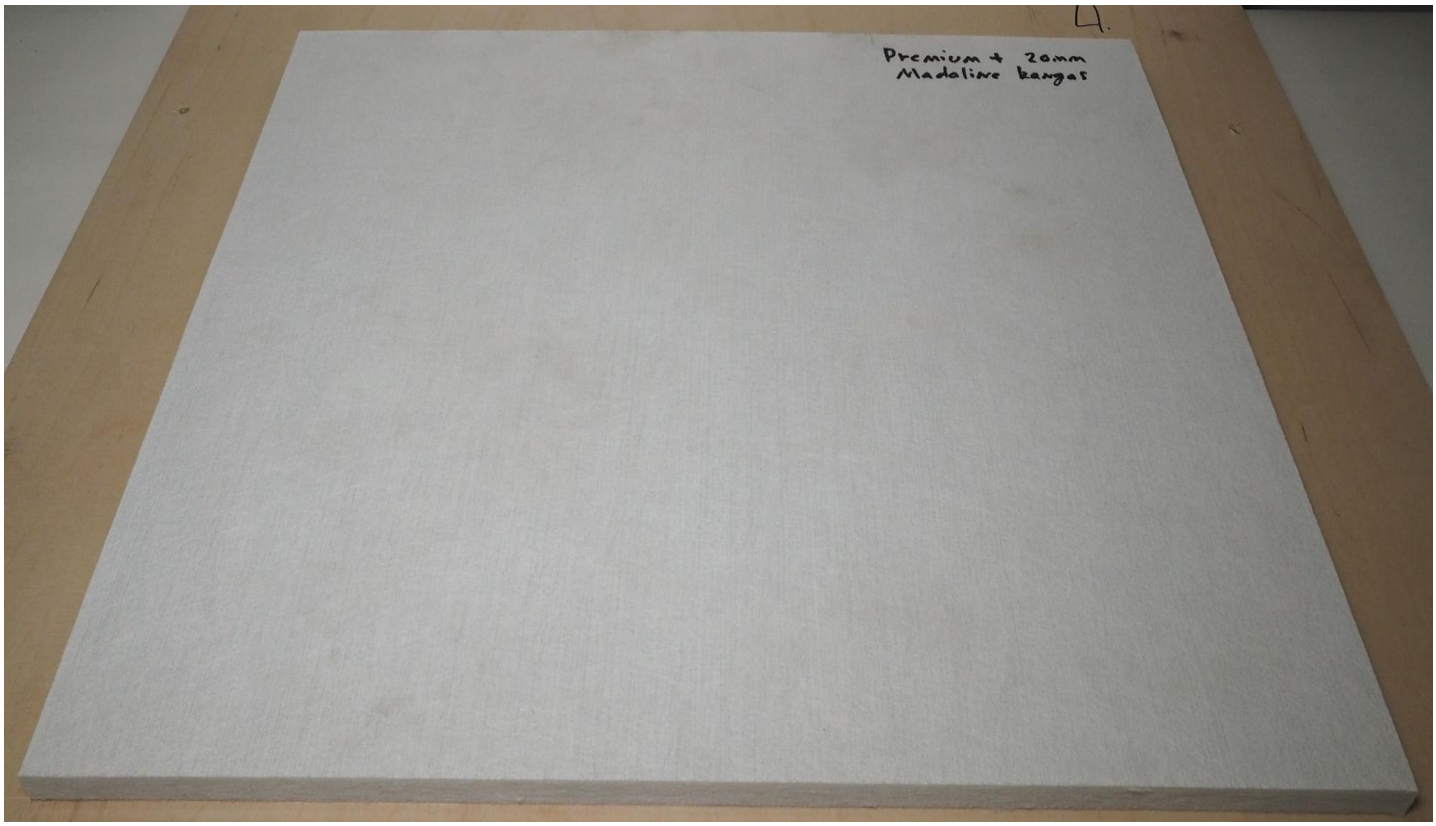
Figure 4. Sample 4 after the test. There were no mechanical defects detected and only visual changes detected were dark ball marks from impact.

Sample 4 functionality was not compromised. Only visual defects detected were dark ball marks caused by impacts.→ Test result is **pass.**

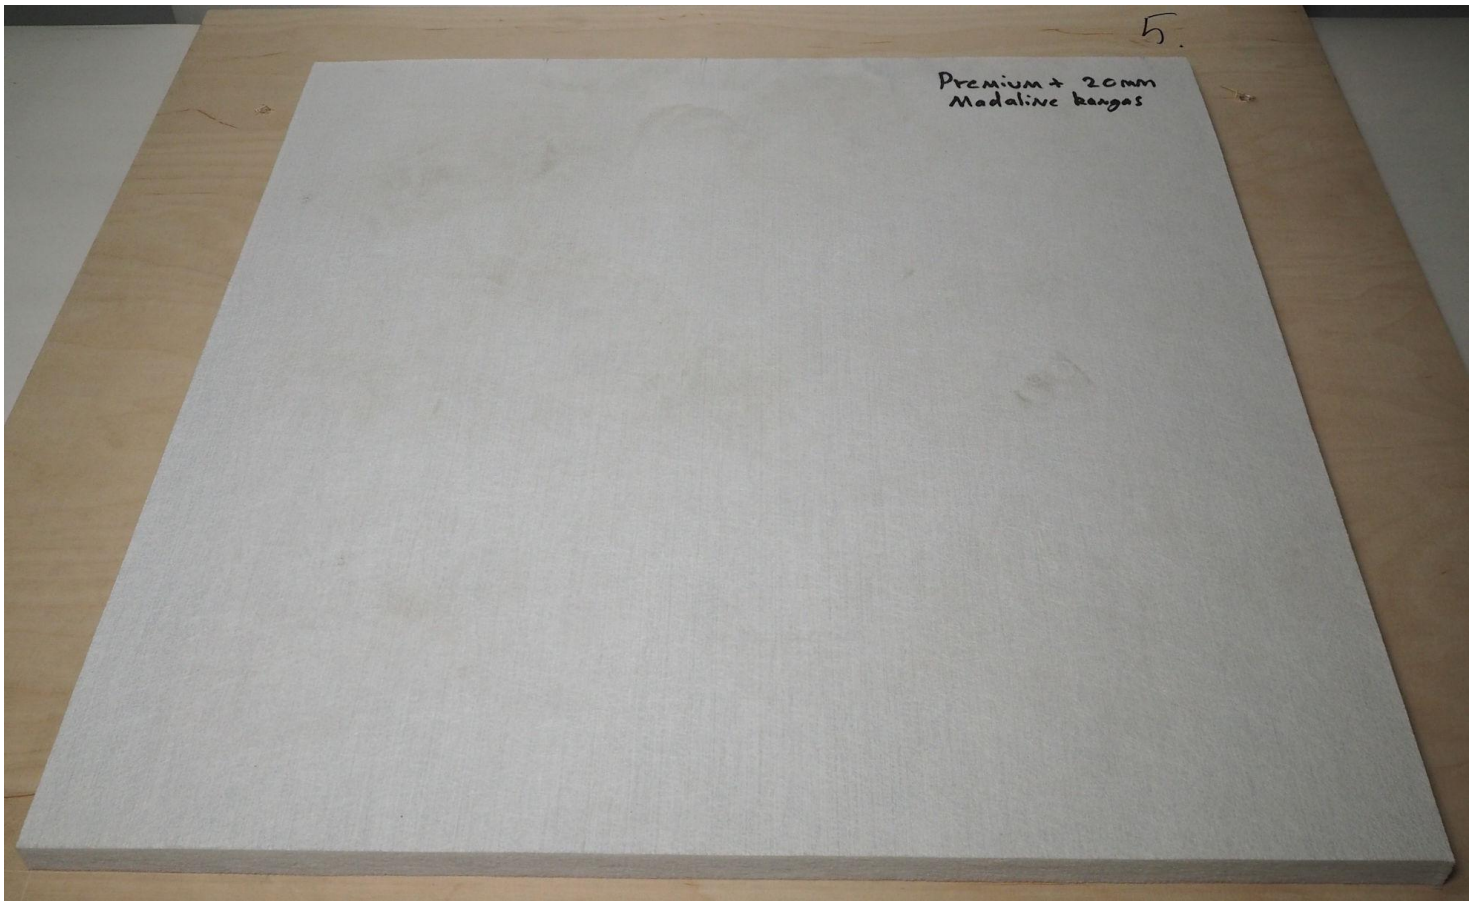
Figure 5. Sample 5 after the test There were no mechanical defects detected and only visual changes detected were dark ball marks from impact

Sample 5 functionality was not compromised. Only visual defects detected were dark ball marks caused by impacts.→ Test result is **pass.**
